Intake Pressure Tester for 2.7T Engine

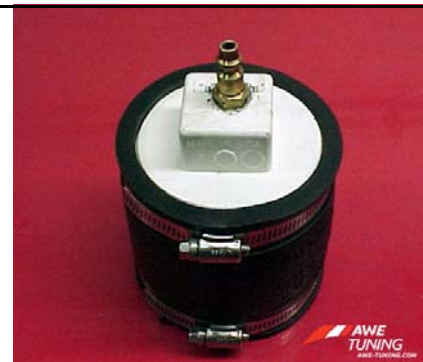
Figure 1: Fitting installed in PVC cap

Thread the air coupler fitting into the cap using the 9/16" box end wrench. The threads on the fitting will cut into the cap and make an air tight seal. Thread the fitting down until flush with the cap, as in Figure 1.

Using the 31/64" drill bit, drill a hole in the center of the PVC cap.

Install the PVC cap into the rubber joining clamp and tighten down the large hose clamp fully.

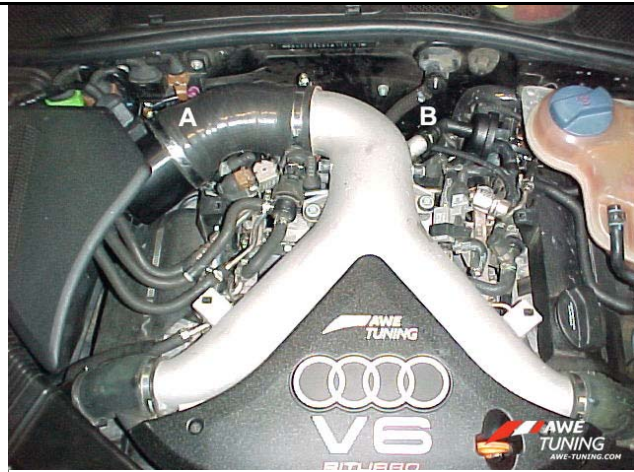
Figure 2: Engine bay

Installation of the tester requires removal of the intake hose running between the MAF and Y-pipe (at point A in Figure 2. AWE RSK04 components shown in Figure 2, but OEM look similar). Use pliers to unload the springs clamps at each end of the hose (flathead screwdriver with AWE RSK04 hose).

Remove the side engine covers (removed in Figure 2).

Unclip the PCV damper from Y-pipe (at point B in Figure 2) by squeezing the clip. Figure 2 shows a 2000 and early 2001 configuration, late 2001 and 2002 will appear similar.

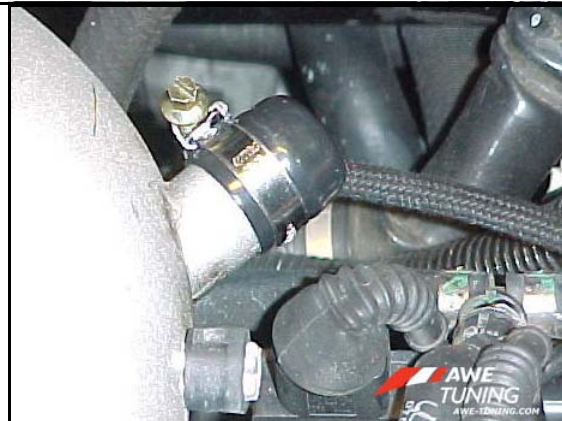
Figure 3: Capping off PCV branch

Close the PCV (Positive Crankcase Ventilation) branch off the Y-pipe with the vinyl cap and hose clamp. Slip the hose clamp over the cap and tighten fully.

Figure 3 shows 2000 and early 2001 configuration. Late 2001 and 2002 will appear slightly different.

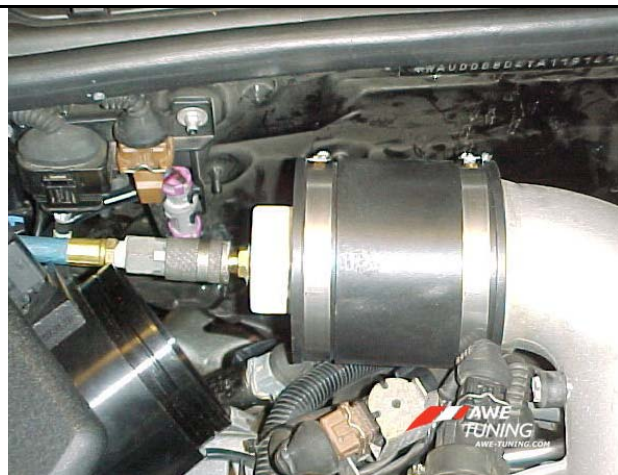
Figure 4: Tester installed

With air pressure turned off, attach the end of an air hose to the air fitting on the PVC cap as in Figure 4.

SLOWLY increase the air pressure to the system via a regulator. No more than 15 psi is needed to expose any leaks in the system. Be sure to stand clear in case the tester pops off.

Slide the rubber clamp assembly over the inlet of the Y-pipe and tighten down the second large hose clamp fully.

With pressure in the system, listen for any leaks coming from the intake and fix as needed. Common leaks are at hose junctions and intercooler end caps.
